FORM B – BUILDING

Town/City: Chelmsford

Address: 122 Boston Rd

Historic Name: Israel Putnam Cider Mill

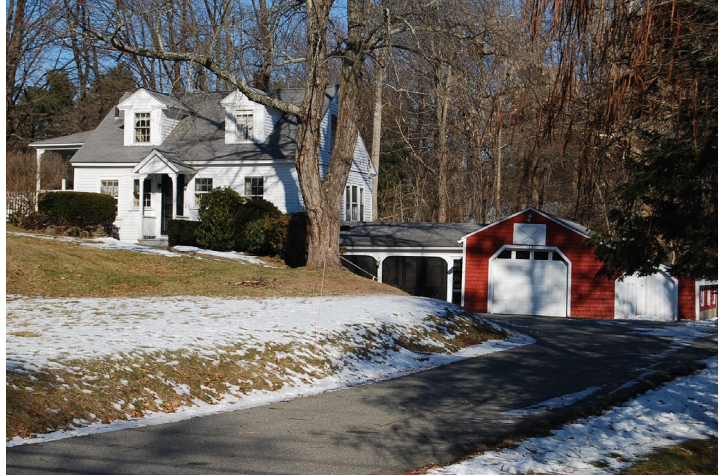
Photograph

View looking northeast from Boston Road.

The 1½-story frame building is symmetrical in plan, five bays wide with a center entrance and two bays deep. The building is clad with wood clapboards and trimmed with cornerboards and a skirt board. The side-gabled building has shallow, overhanging eaves with gable-end cornice returns. An interior brick chimney rises from the center of the roof ridge. Two gable dormers with cornice returns, each containing a single window, are located on the west roof slope. A side-gabled frame screened porch connects the south elevation to the garage south of the house. Windows throughout the building are 6/6 wood sash. The wide, flat window surrounds feature a slender, molded backband.

Square-section wood posts with curved brackets support a front-gabled porch with overhanging eaves that shelters the center entrance. Square-section balustrades enclose the north and south side of the small porch. The paneled wood door is flanked by two small windows, with two larger windows at the outer bays. A hipped-roof porch with square-section wood posts and curved brackets similar to those at the entry porch is attached to the north elevation.

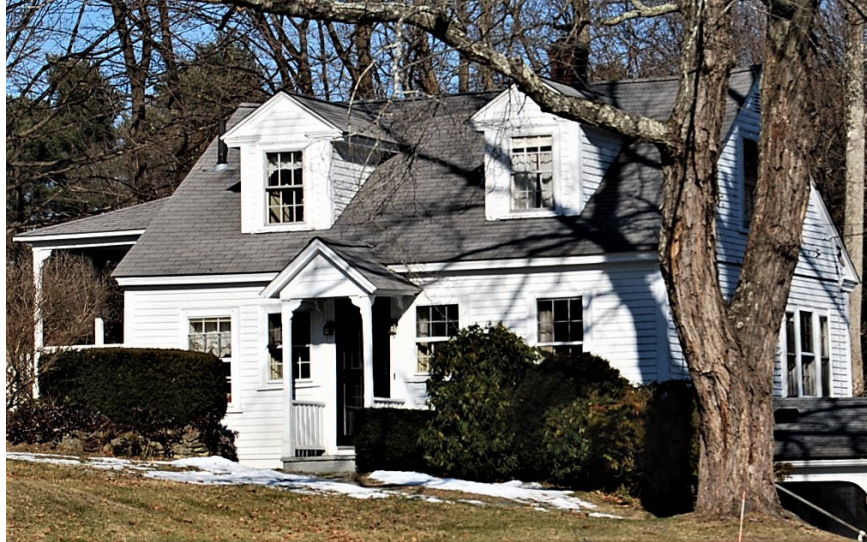
View looking northeast.

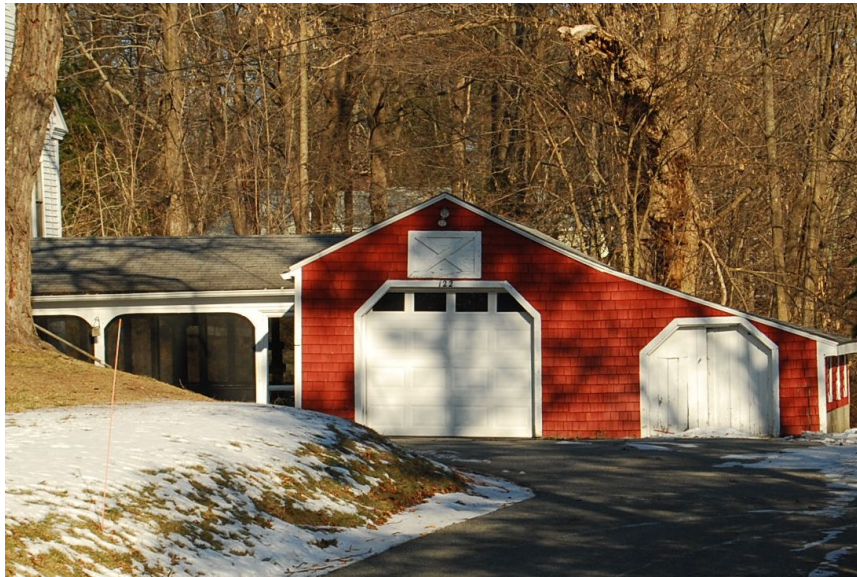
The garage features an asymmetrical gable roof that shelters a single vehicle bay at the north end and a storage bay at the south end. The wood-shingled building rests on a poured concrete foundation. A *faux* battened loft door is centered above the garage bay, which contains a replacement metal overhead door. The smaller storage bay contains side-hung vertical board doors. The south elevation contains three small square windows.

Garage. View looking east.

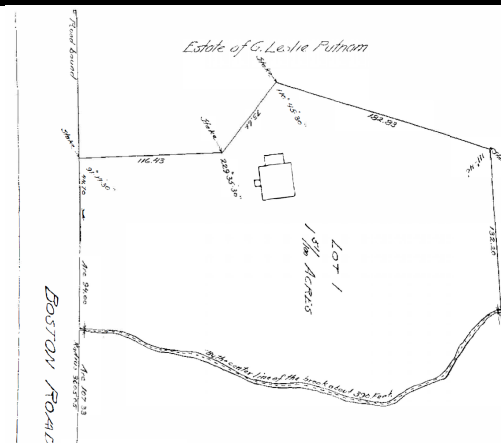
Based on its appearance, the building was likely converted to a dwelling house in the second quarter of the 20th century. A 1943 plan of the property depicts the house with the façade porch and north elevation porch. (See below.)

The property in 1943. Middlesex North Registry of Deeds Plan Book 65, Plan 97.

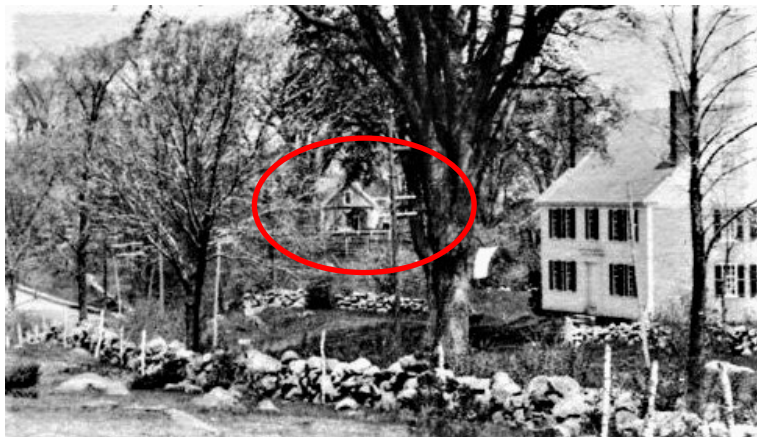
The side (south) elevation contains two bays of triple windows. A pair of windows is located in the gable peak. A projecting stringcourse is located between the first floor and attic of this elevation. The basement level is sheltered by the screened porch.

South elevation of mill at center, as seen circa 1907-1915. 134 Boston Road visible at right. "On the Boston Road. Photo No. 15." Postcard. Arnold C. Perham Collection. Object ID: 2013.2.3046. Chelmsford Historical Society.
