# FORM B – BUILDING

CLM.327

**Address:** 203 Boston Road

**Historic Name:** Henry Spaulding House

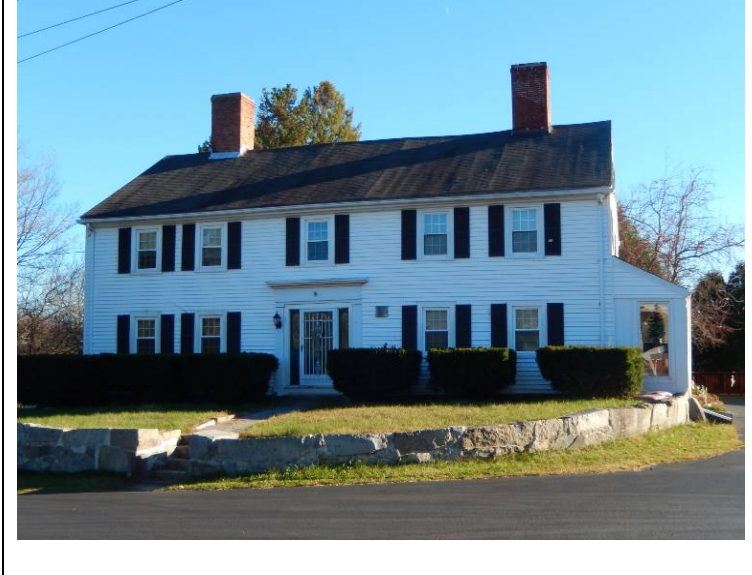
## Photograph

The 2.5-story house has a stone foundation, walls clad in replacement vinyl siding with vinyl trim, and a side gable asphalt-shingled roof. Two internal brick chimneys are located along the ridgeline of the roof. Most of the fenestration in the building consists of replacement six-over-six double-hung windows with false muntins. The window openings have decorative shutters. The primary (north) façade is five symmetrical bays wide and faces away from Boston Road. Single windows are located in the four outer bays of the first and second stories. A single window is also located in the center bay of the second story. The main entry in the center bay of the first story features a replacement door and sidelights with a simple molded surround. The east and west walls are two bays deep with single windows in most of the bays. A three-pane casement window has replaced a historic window opening in the first story south bay of the east wall. A one-story enclosed porch with a shed roof has been added to the west wall. An undated photograph of the house shows it once included a one-story summer kitchen off the rear wall; this building has since been removed. An undated historical photograph of the house is available in *Images of America: Chelmsford*.

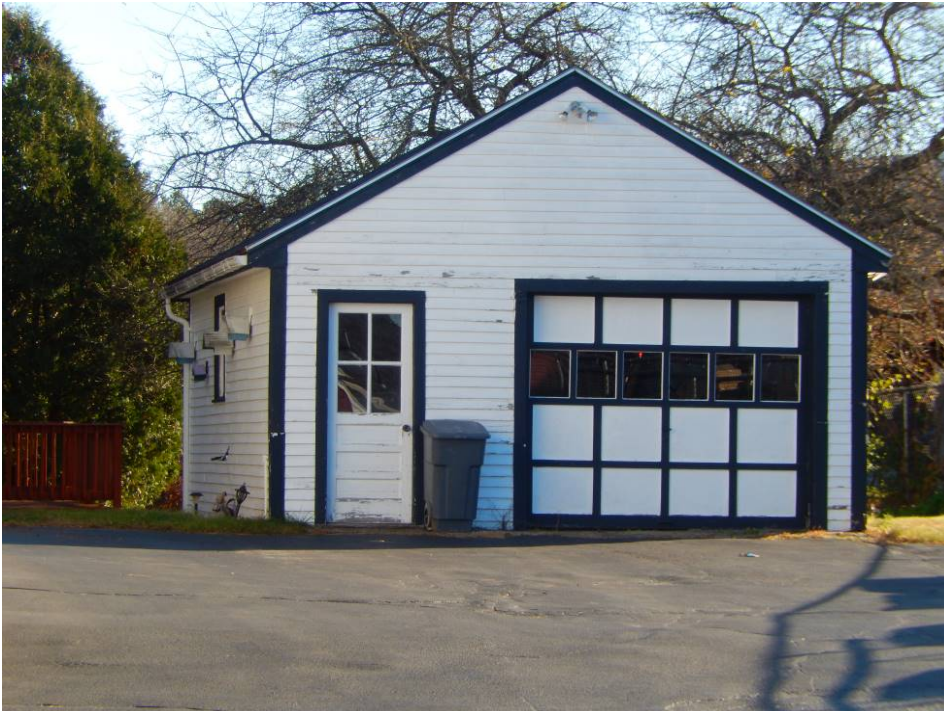
A detached garage is located to the southwest of the house. The garage is clad in wood siding with wood trim and had a front gable roof. The primary (north) façade includes a pedestrian door in the east bay and a replacement rollway garage door in the west bay. Until ca. 2010 an above-ground pool with a deck was located behind the garage. The pool was removed at this date, but the deck remains. A shed building is located to the rear of the deck. The shed is one bay wide and two bays deep with a front gable roof.

Detached garage,  
facing south.  
November 2015.
