# FORM B – BUILDING

**Town/City:** Chelmsford

**Address:** 24 Central Square

**Historic Name:** Mill House

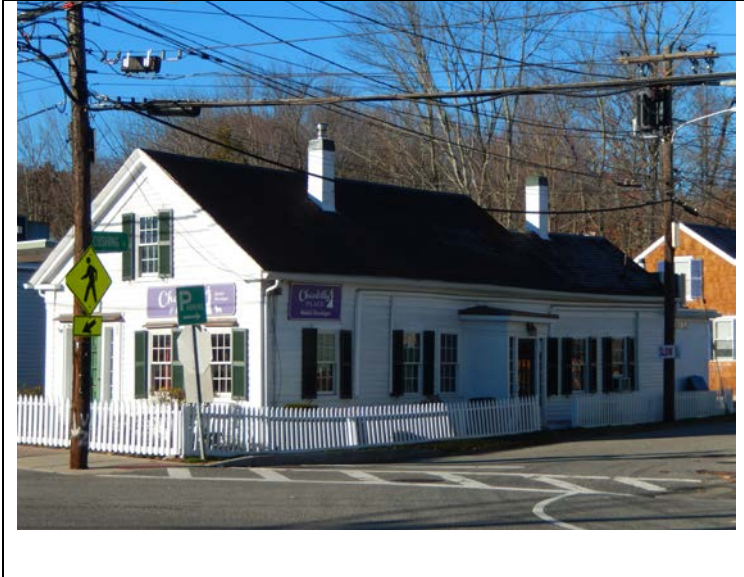
## Photograph

The resource is a 1.5-story building constructed in 1846 in the Greek Revival architectural style. The building has a stone foundation, walls clad in wood clapboard with wood trim, and has an asphalt-shingled front gable roof. The front gable features a raked cornice and gable returns. The building has two internal brick chimneys: one on the north slope of the roof near the center of the ridgeline and one along the ridgeline of the rear 1877 portion of the building. Fenestration throughout the building consists of six-over-six double-hung windows; most windows feature shutters with historic shutter hardware. The primary (east) façade is three bays wide on the first story and features corner boards. Windows are in the north and center bays. The main entry is in the south bay and features a solid wood door with a glass and wood storm door surrounded by six-pane sidelights. Short metal awnings slightly shelter the doorway and windows on the first story. A window is below the gable peak of the half story. The north wall is seven bays deep with windows in the outer bays. A secondary entry in the center bays projects from the building and features a glass door with sidelights. The 1877 rear counting house addition is one-story tall. A 1997 concrete block rear addition was constructed at the rear of this portion of the building. Also at this date a new building was added to the lot to the west.

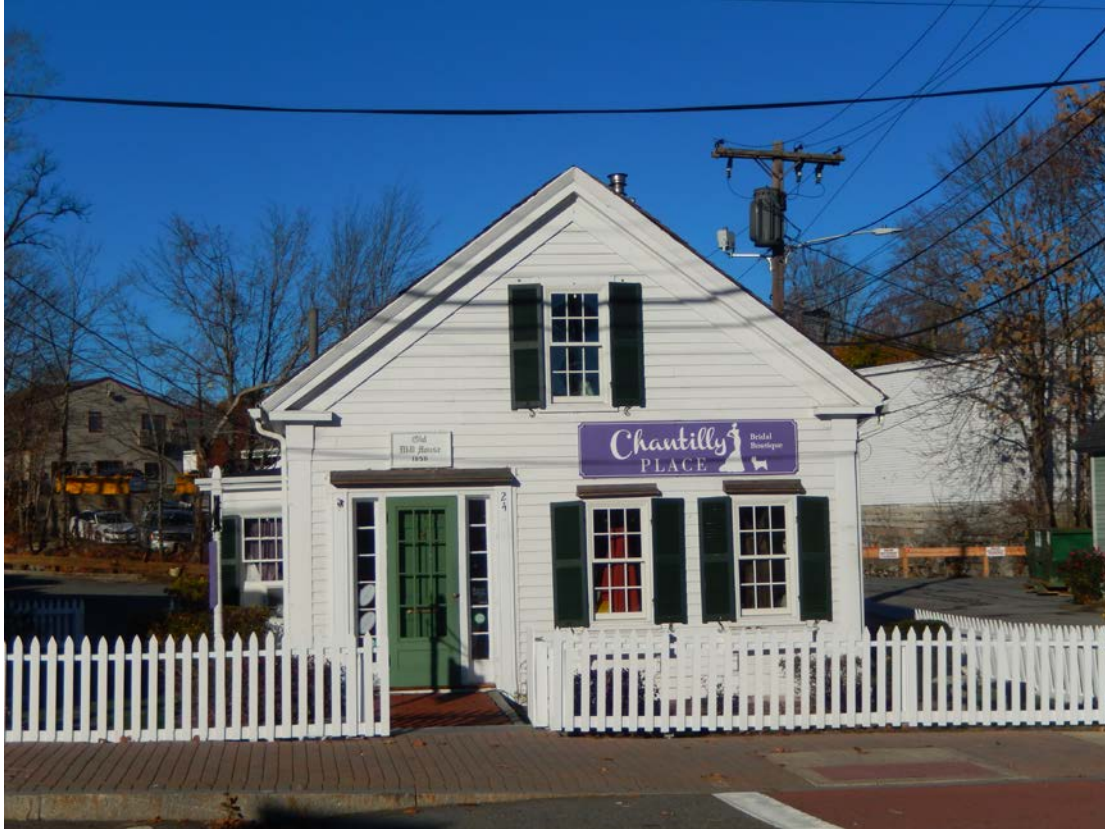
24 Central Square, primary façade, facing west. November 2015.
