FORM B – BUILDING

CLM.334

Address: 37-38 Central Square

Historic Name: George and Daisy Day Building

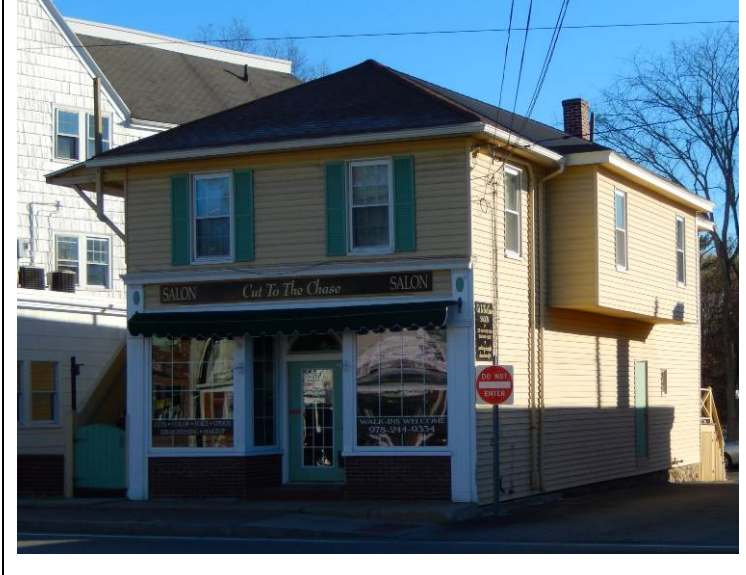
Photograph

This two-story building, with basement, has a stone foundation, walls clad in replacement vinyl siding, and a asphalt-shingled hipped roof. An internal, brick chimney is located along the south slope of the roof. Windows throughout the building are replacements, with one-over-one, double-hung windows on the north and south walls and six-over-six double-hung windows with false muntins on the second story of the primary (west) façade. The three-bay, symmetrical, primary façade includes storefront space on the first story and two, single windows on the second story. The storefront has large, display windows on the north and south bays and a single, recessed entry door in the center topped with an oval-shaped transom. Many of the storefront materials are replacements, including the multi-pane windows with false muntins, brick-covered kickplates, and entry door. The trim on the storefront appears to be historic, including the wooden, fluted pilasters at the corners of the windows and at the ends of the façade. The end pilasters are topped with a simple moulded capital; above this is a flat ornamentation with a plain, oval medallion and dentil moulding. A retractable awning is located above the storefront windows and extends across the width of the façade. A signboard space is above the awning and currently features a modern sign for the salon in the building. The storefront area is topped with a full-width, moulded piece that separates the stories.

The north wall features a partially-enclosed staircase that leads from the sidewalk to the apartment unit on the second story. The staircase is sheltered by a shed roof awning supported by knee braces. The east end of the north wall includes a one-story, shed roof addition that is clad in replacement siding. The south wall features a single door and window on the west end of the first story. The four-bay second story features single windows in each bay with the center two bays projecting outward. A modern, wood deck is located on the rear wall.

The resource is an altered example of a mixed-use building. It retains historic integrity of location, setting, feeling, and association. The building is adjacent to the Chelmsford Center Local and National Register Historic District.

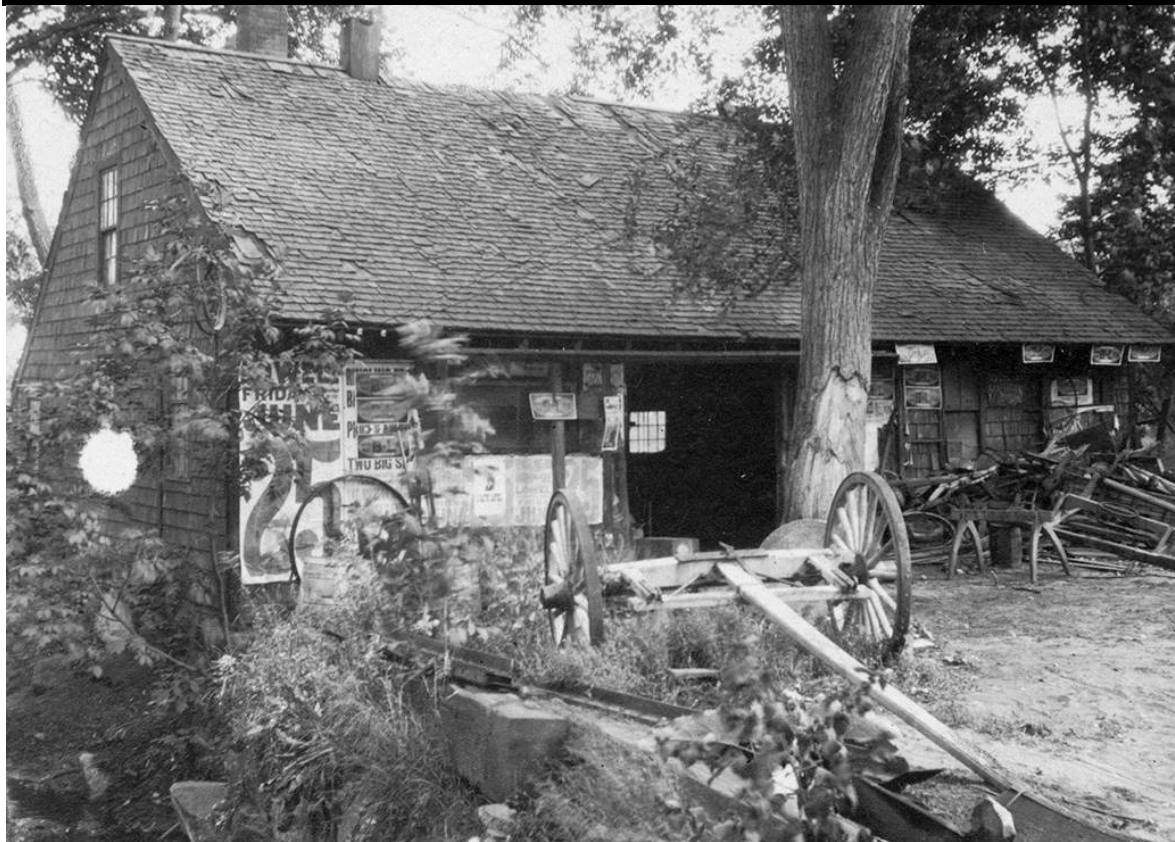
Photograph of the blacksmith shop taken in September 1920. (Chelmsford Historical Society.)

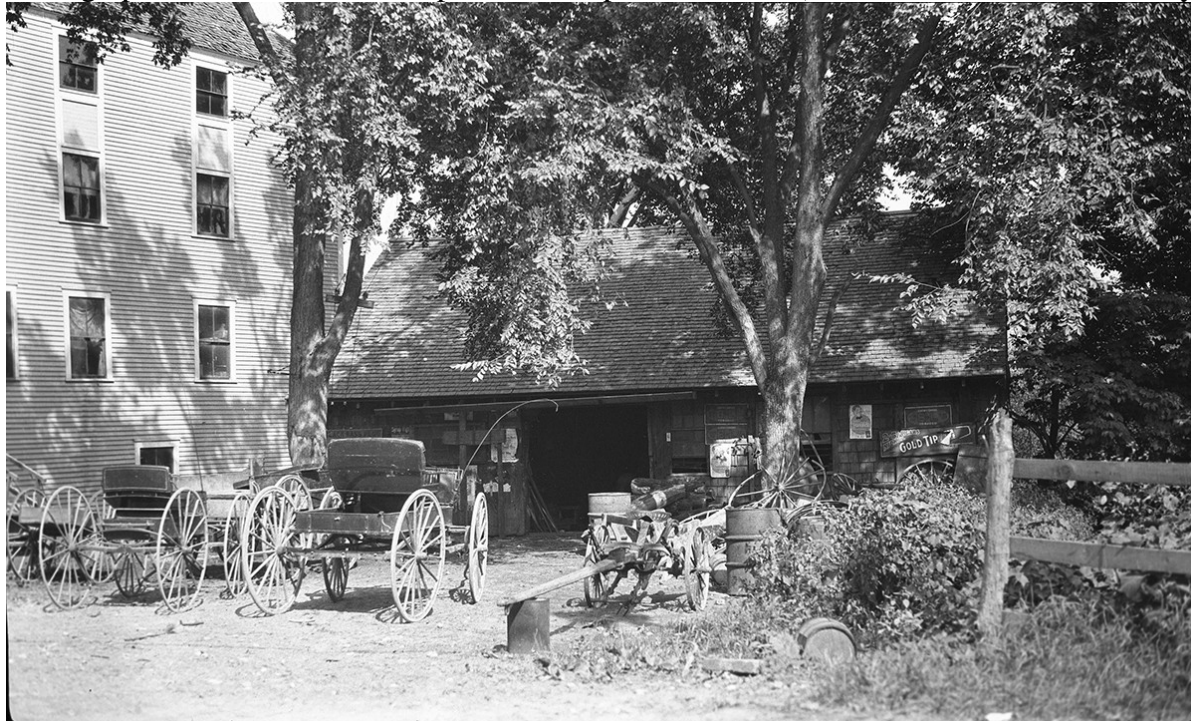
Ca. 1900 photograph of the blacksmith shop with the Independent Order of Odd Fellows building (CLM.249) in the left background. (Chelmsford Historical Society.)
