FORM B – BUILDING

CLM.337

Address: 105 Garrison Road

Historic Name: Byam Blacksmith Shop

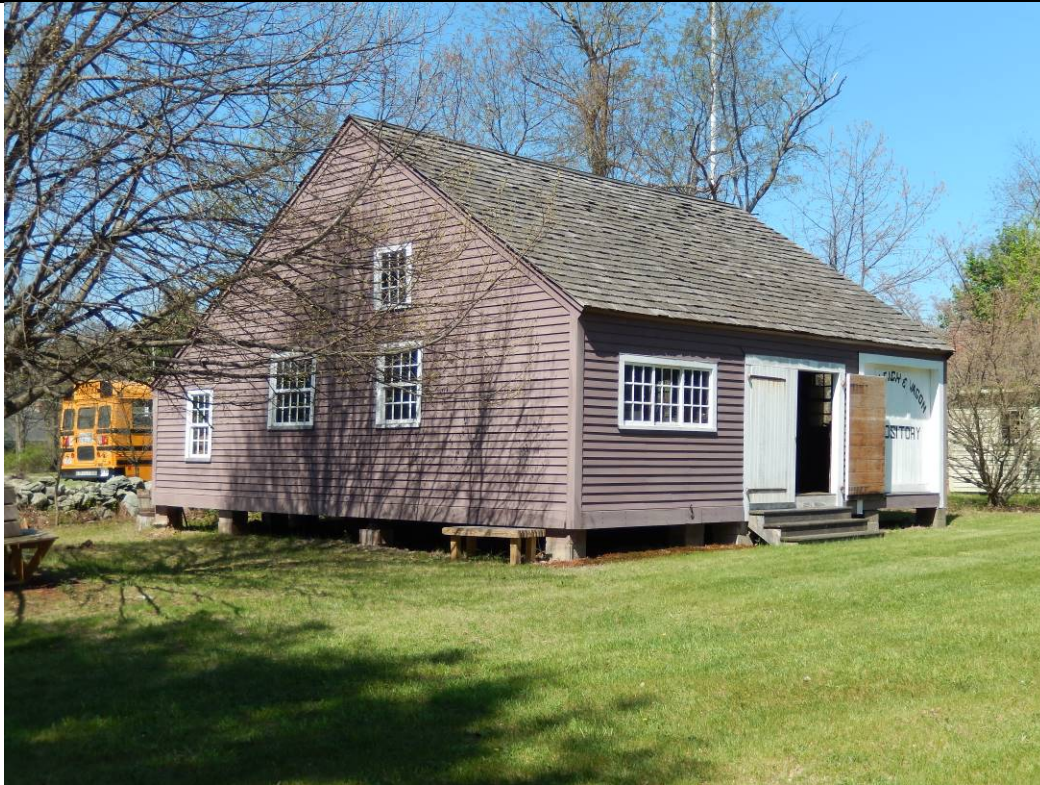
The 1.5-story blacksmith shop has a pier foundation, walls clad in wood clapboard with wood trim, and a side gable roof covered with slate shingles. An internal brick chimney on the rear slope of the roof is utilized for the forge. A set of three wood steps lead to the centrally located main entry on the east wall. The entry has a set of wood doors with iron hinges. A 27-pane wood window is to the south of the door. A wagon door is north of the entry door. The north wall is four bays deep with three windows and a pedestrian door on the first story and a casement window on the half story. The south wall mirrors the north, but lacks a doorway. The interior of the building is one open room because its king truss construction that allows the truss to support the roof system without interior walls or other supports. The building has a wood floor.

Primary façade and south walls, facing northwest. May 2016.

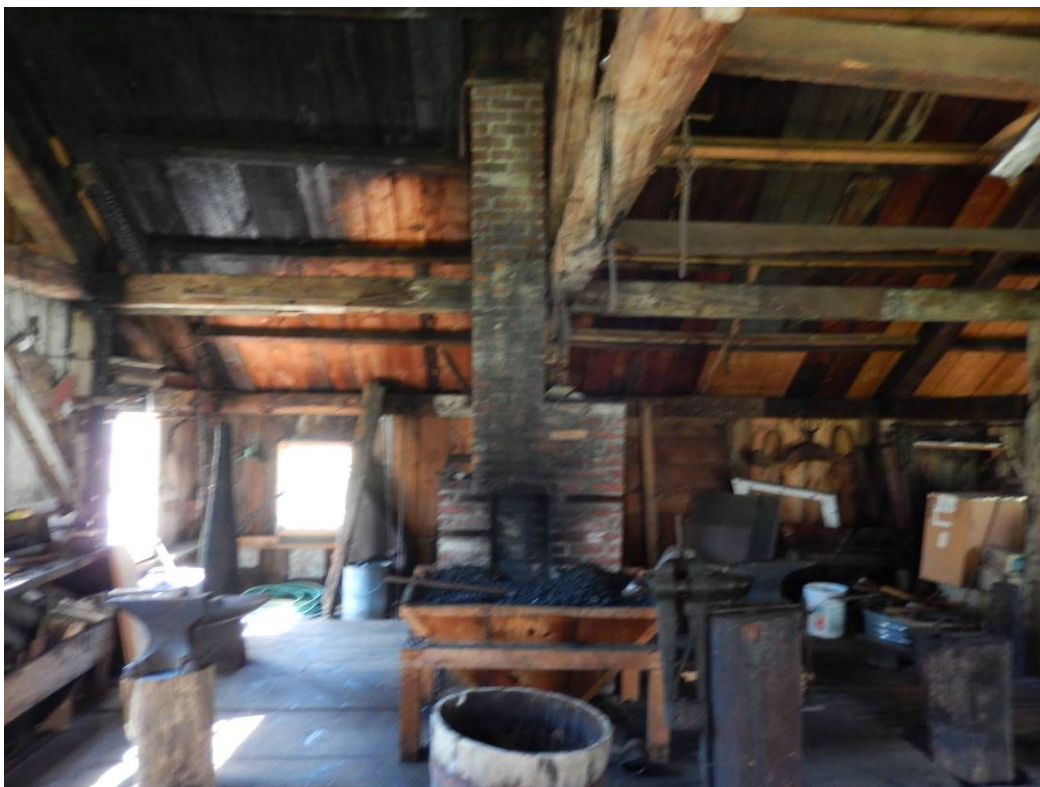
The forge is on the south half of the building and features an uncommon wood hearth. A fire in 1998 charred many of the trusses (see photograph below). Fortunately, the fire was contained before the potential loss of the building. The building also exhibits numerous examples of historical blacksmith tools and implements.

Interior of blacksmith shop, showing forge and charred portions of the ceiling. May 2016.

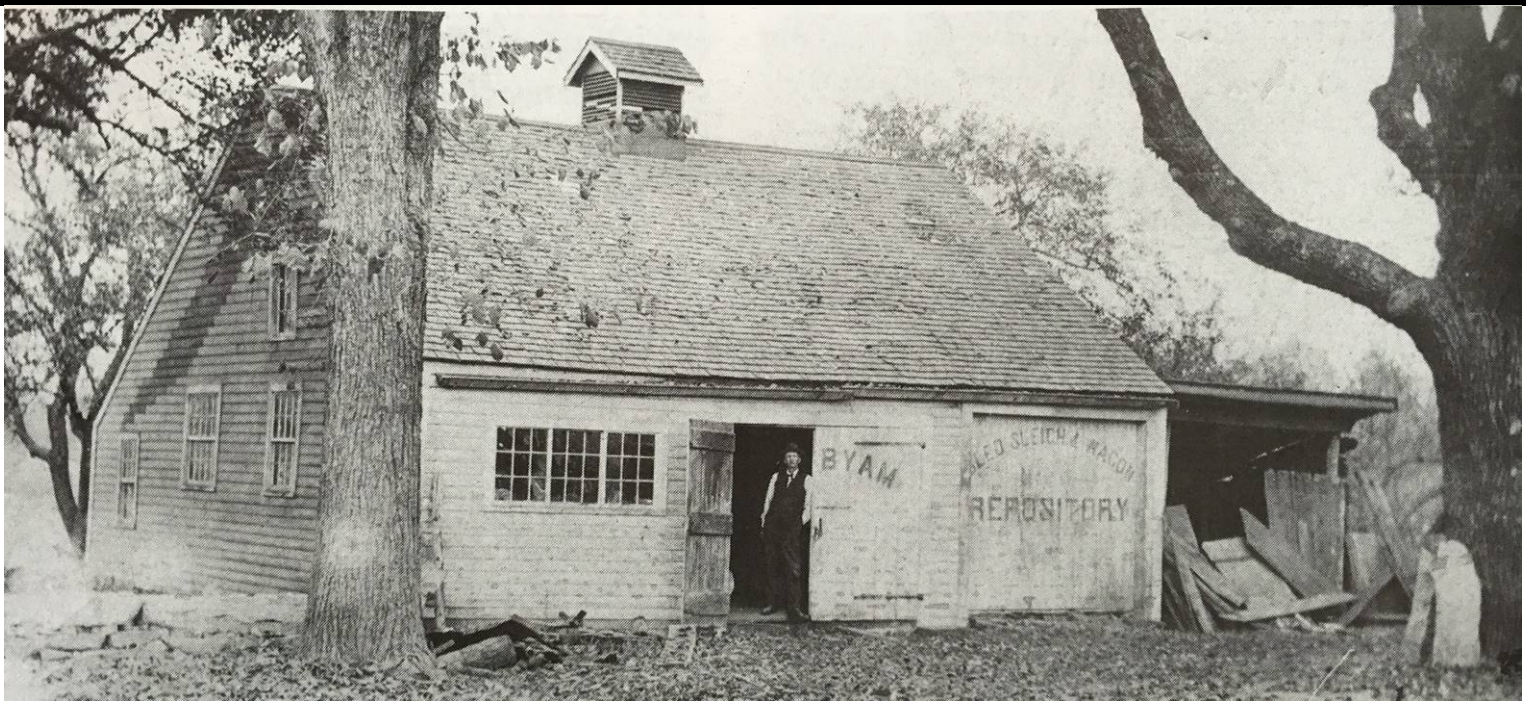
1908 photograph of the blacksmith shop in its original location on Maple Road. (Chelmsford Historical Commission/ Linda Prescott.)
