FORM B – BUILDING

Town/City: Chelmsford

Address: 105 Garrison Road

Historic Name: Fiske Barn

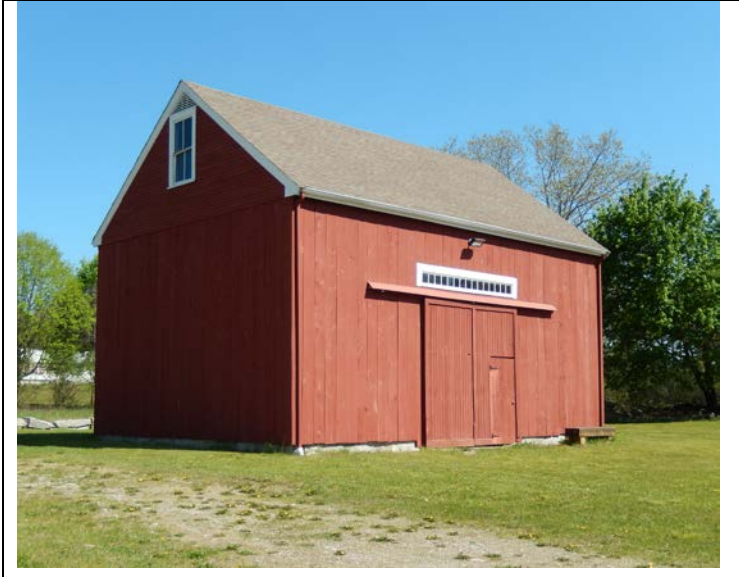
Photograph

The barn has a granite foundation, walls clad in vertical wood planks with wood trim, and has a side gable, asphalt-shingled roof. A central passageway travels across the non-gabled southeast and northwest sides of the barn. These wagon doors are on sliders and both are topped with multiple-pane transoms. The door on the southeast wall features a pedestrian door within its east corner. Another pedestrian door is at the west corner of the northwest wall. The gables are clad in horizontal wood clapboard and include wood, two-over-two, double-hung windows below the gable peaks.

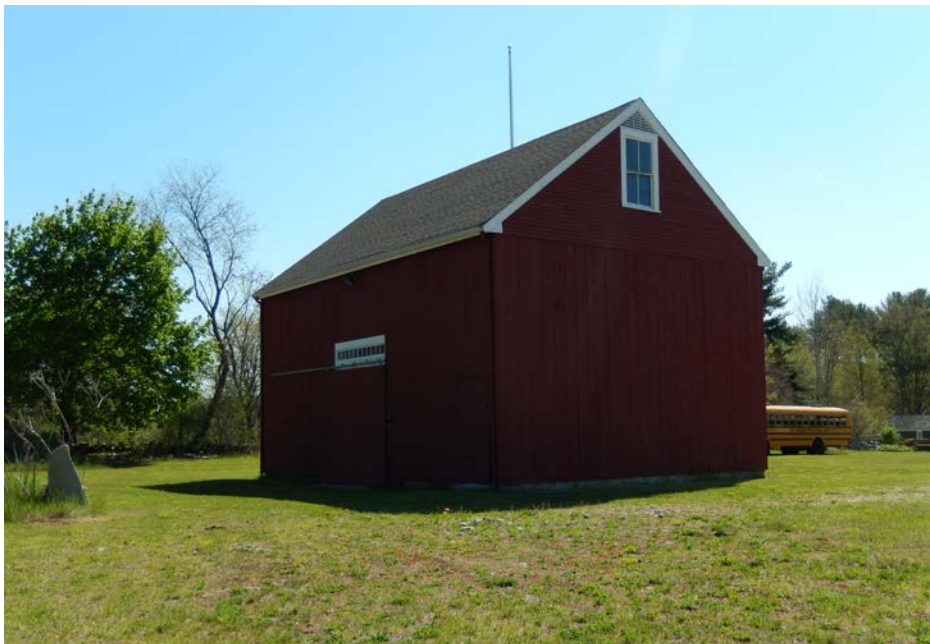
Rear and north walls, facing southeast. May 2016.
