FORM B – BUILDING

Town/City: Chelmsford

Address: 29 Gorham Street

Historic Name: Robert and Martha Barris House

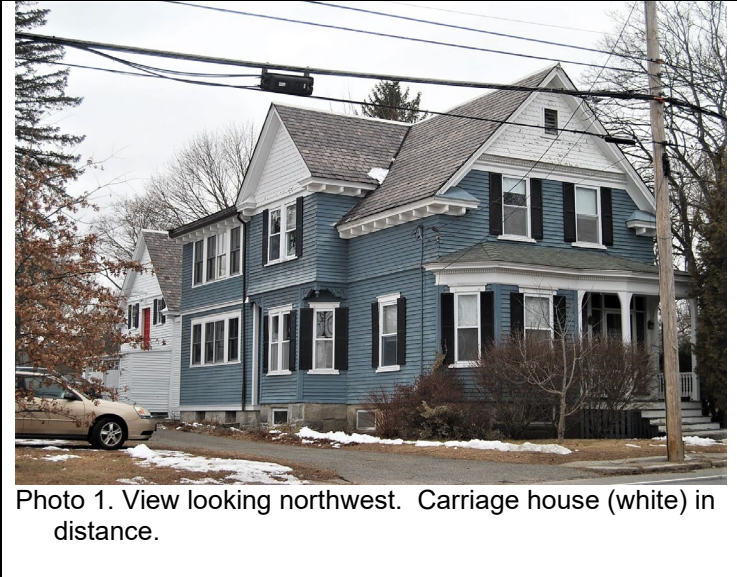
Photograph

Condition: Poor (Historic integrity high; fire damaged)

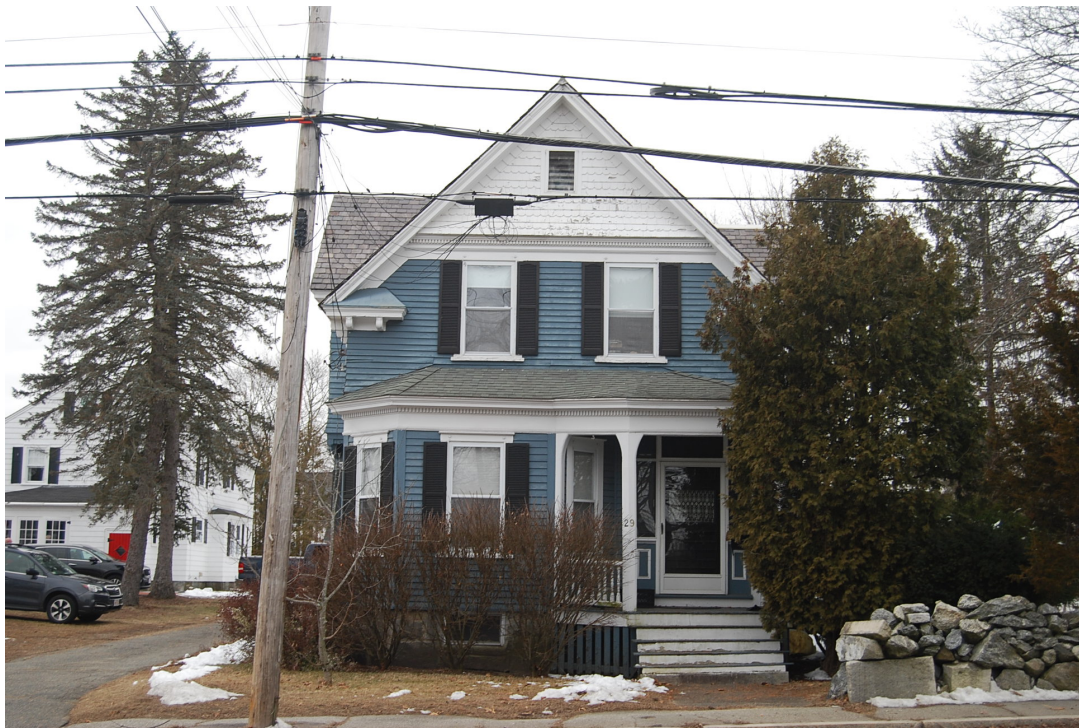
Photo 2. East Façade.

The main block has a front-gabled roof with gable-end cornice returns and overhanging eaves. (Photo 2) Renaissance Revival-style compound brackets are located beneath the eaves on all elevations. The building is sheathed with wood clapboards with a flared kick course between the first and second floors. The gable peaks feature shingled imbrication. Windows throughout the house appear to be 1/1 vinyl replacements with flat wood surrounds and a molded cap. The surrounds retain the hooks for the original storm windows. Screw-on vinyl shutters are located throughout the house. The high foundation is ashlar granite on the east and south elevations and uncut stone on the north and west elevations.

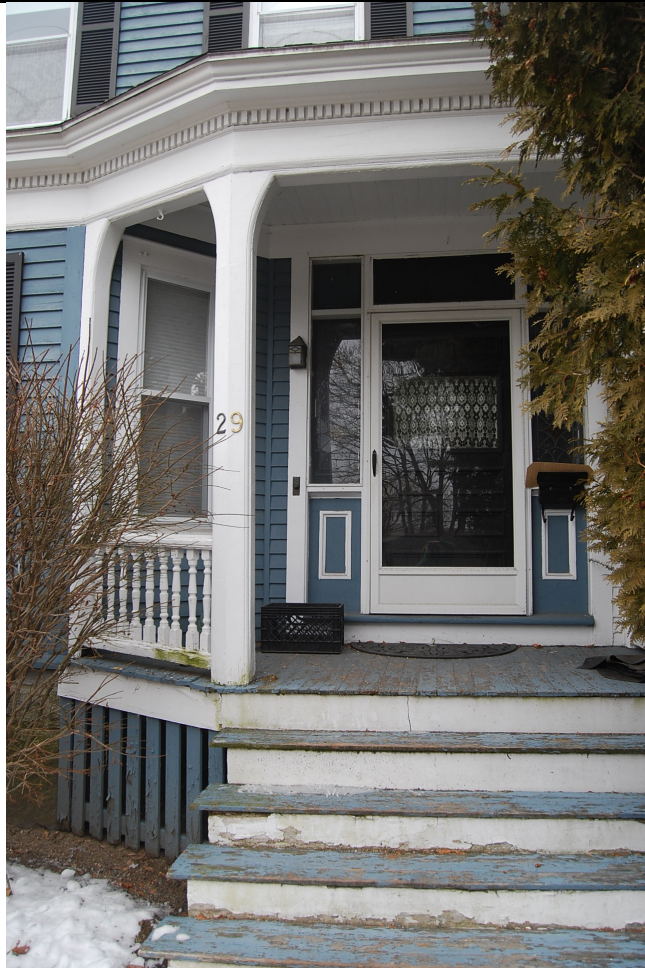
Photo 3.
Detail.
Porch.

At the first floor of the east façade, a hipped-roof projection contains a bay window at the south end and a porch at the north end; the second floor contains two window bays. The projecting bay and porch feature a robust fascia surmounted by two courses of molding, a dentil molding, and a box cornice. (Photo 3) A similar course delineates the second floor of the façade from the gable peak. Alternating rows of square and octagonal wood shingles fill the gable peak and end with a row of sawtooth shingles that flare over the top of molding course. (Photo 4) A dressed, cut-granite step leads from the concrete walk to the wood porch stairs. The porch is enclosed on two sides by balustrades with turned spindles and is supported by chamfered posts with graceful curved spandrels. The posts' upright boards are set at an obtuse angle to mimic the three-sided projection of the porch roof. The porch shelters a large paneled wood door with a light in the top half and an Eastlake-style metal doorknob and escutcheon. (Photo 5) An Eastlake-style doorbell and escutcheon are located on the molding at the south edge of the entablature. (Photo 6) The entablature features a broken transom with leaded stained-glass sidelights and transom; the corner lights appear to be large single lights of stained glass. The porch floor is constructed of tongue-and-groove wood boards.

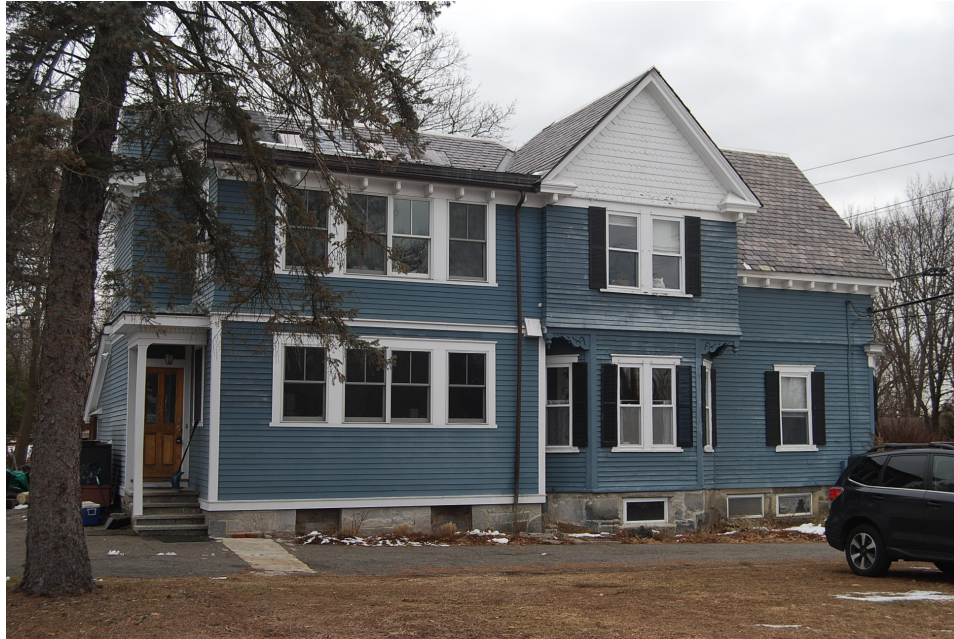
The south elevation contains a single bay at the first floor of the main block and a single bay of paired windows in both stories of the cross-gabled projection. (Photo 7) The first floor of the projection contains a cutaway bay window with jigsawed wood brackets and turned wood pendants. The projection's gable peak features a shingle pattern similar to that located on the façade but has a simple fascia instead of a compound molding course. (Photo 8)

Photo 7. South elevation. Recent addition is located to left of cross-gabled projection and contains rows of four grouped windows.

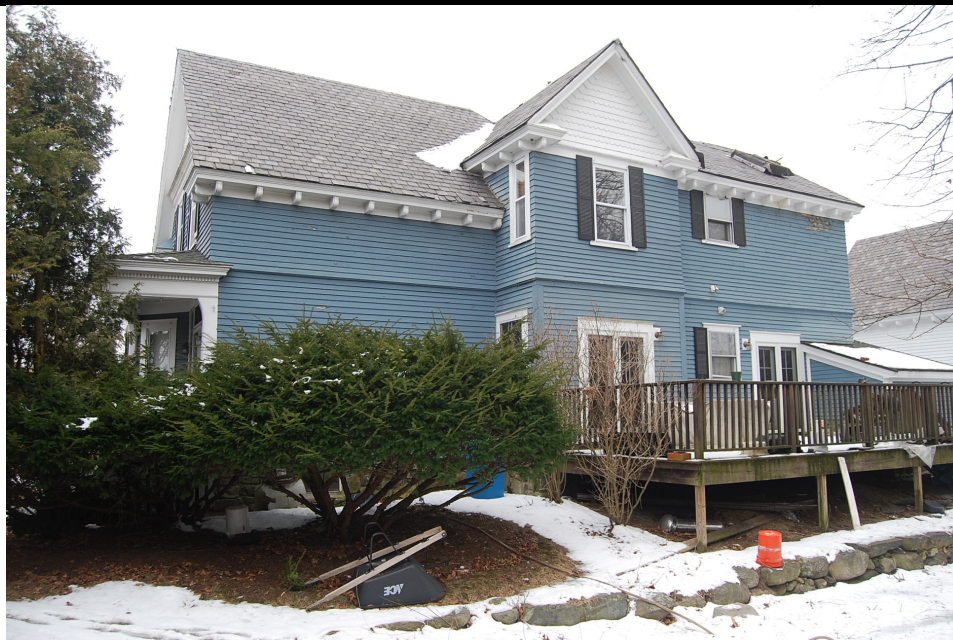
Photo 9. North elevation.

The north elevation does not contain any windows at the first floor of the main block. (Photo 9) The cross-gabled projection contains a window at the second floor and modern French doors at the first floor. The east elevation of the projection contains one window in the first and second floors. The projection's gable peak features a shingle pattern similar to that located on the façade but has a simple fascia instead of a compound molding course. The rear ell contains a single window at the second floor and a window and French door at the first floor. A late 20th C wood deck is located along the rear half of the elevation.

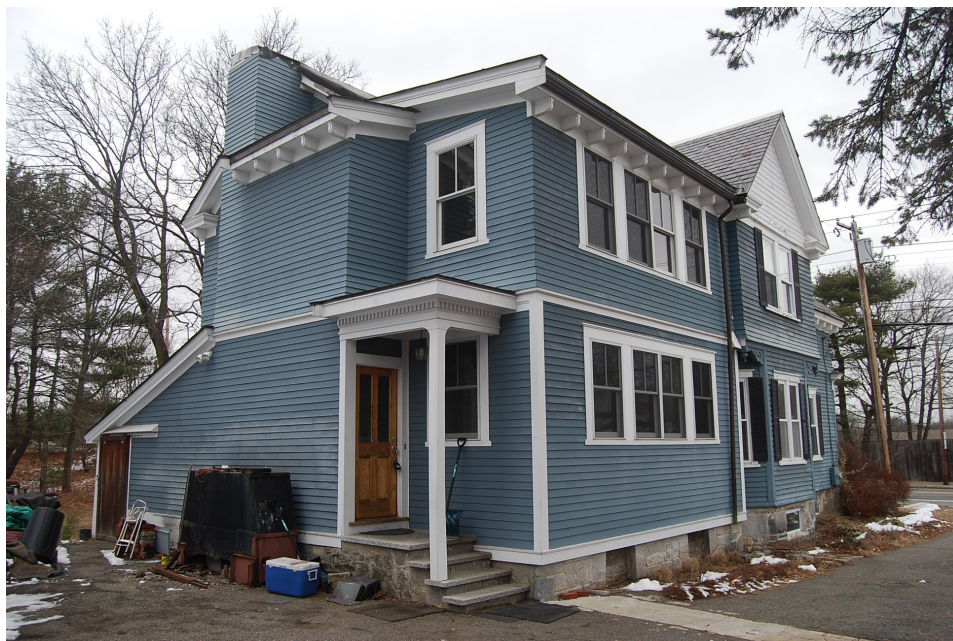
A recent addition is located at the southwest corner of the house. (Photo 10) The two-story addition rests on a cut stone foundation and features a row of four windows on the first and second floors of the south elevation. The west elevation contains an entrance covered by a small porch. A clapboard-clad projection centered on the elevation contains a chimney. Care has been taken in the construction of the addition to mimic the brackets used the original house, to echo the kick in the clapboards between stories, and to face the foundation with cut stone.

Photo 10. Recent addition at rear. West and south elevations. View looking northeast.
