FORM B – BUILDING

Town/City: Chelmsford

Address: 231 Main Street
Historic Name: Dawson Pollard House
Uses: Present: single-family dwelling
Original: single-family dwelling
Date of Construction: 1837
Source: Chelmsford tax records
Style/Form: Federal
Architect/Builder: Dawson Pollard
Exterior Material:
Foundation: stone
Wall/Trim: vinyl siding/vinyl
Roof: asphalt shingle

231 MAIN STREET

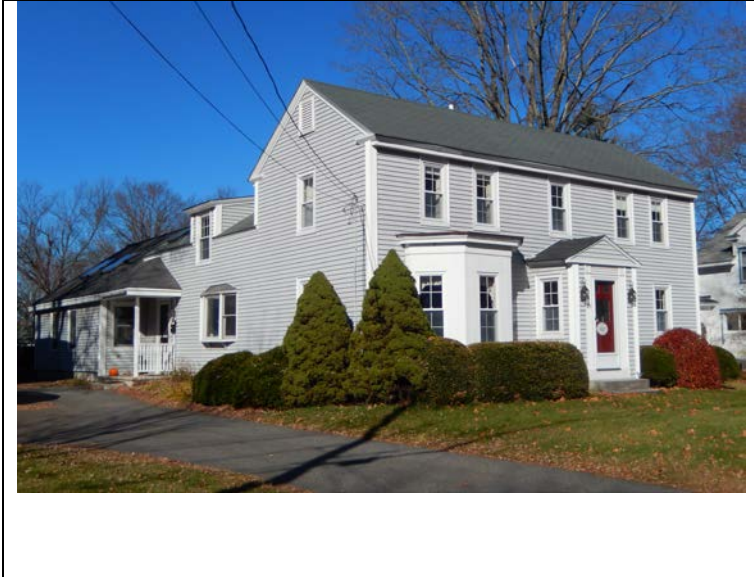
Photograph

Major Alterations (*with dates*):
Ca. 2000 replacement windows and siding
1988 rear addition
1986 fenestration change

Condition: Fair

The two-story building has a stone foundation, walls that are clad in replacement vinyl siding with vinyl trim, and an asphalt-shingled side gable roof with gable returns. Two, internal chimneys are located on the rear slope of the roof near the gable ends (previous interior inspection in 1990 revealed the east chimney had been removed). Most windows in the main mass of the building are replacement, four-over-four, double-hung sash windows with false muntins. The primary (southeast) façade is five bays wide with single windows in the bays on the second story. The first story includes single windows in the two east bays and an oriel window in the west bay. The center bay includes a one-story, one-bay deep projection with a front gable roof that includes the main entry. The entry has a replacement door and a fluted surround. A 1.5-story wing is located at the rear of the west half of the building. The wing is two bays deep with a bay window in the south (this bay replaced two single windows at this location in 1986) and a secondary entry in the north bay. The half story features a single shed roof wall dormer. The rear of the building was further expanded in 1988.

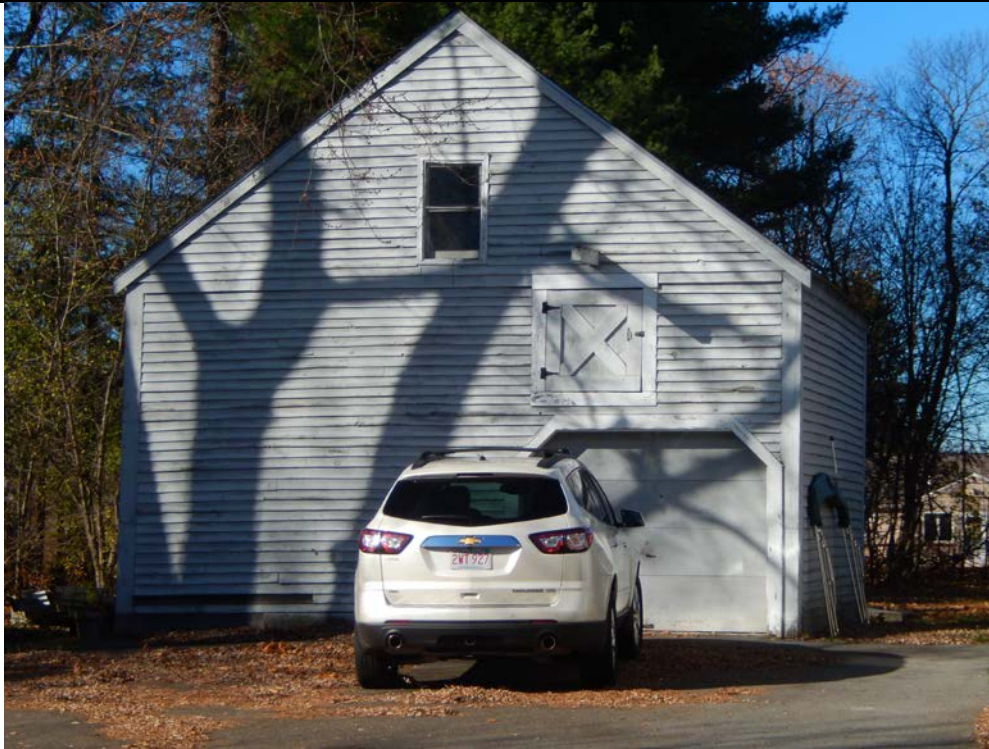
A barn that has been converted into a garage is located to the west of the rear addition. The garage has a stone foundation, walls clad in wood clapboard with wood trim, and a front gable roof. The primary (southeast) façade includes a single garage door on the east half of the first story, a hay loft door and post above that, and a single window below the gable peak.

Carriage house, facing northwest. November 2015.
