FORM B – BUILDING

Town/City: Chelmsford

Address: 126 Proctor Road

Historic Name: Rufus and Sarah Harwood House

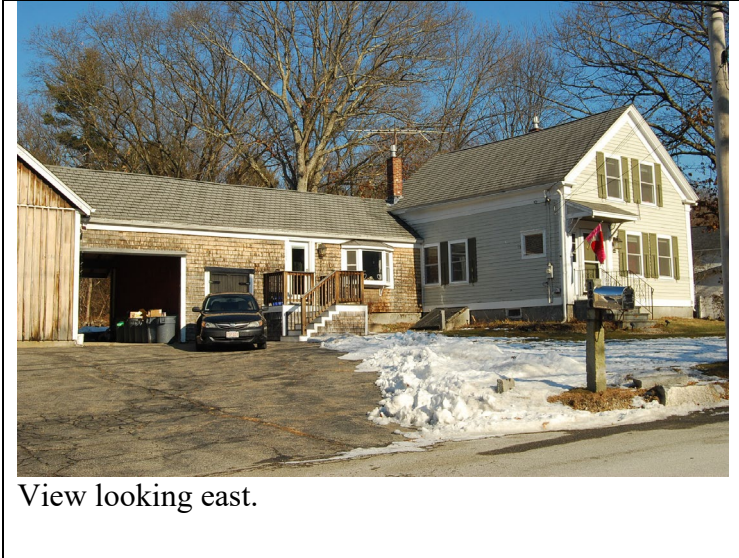
Photograph

The 1 ½-story frame house is two-over-three bays wide with a side hall plan and three bays deep. The building rests on a cut stone slab foundation. The front-gabled roof has overhanging eaves. A slender brick interior chimney rises from the east roof slope; a similar chimney rises from the northwest corner of the house. The building is clad with wood clapboards and trimmed with a wide frieze and skirtboard. Corner pilasters rise to meet the gable-end cornice returns. A shed-roof porch with Eastlake-style turned wood brackets shelters the entrance. The Colonial-Revival-style front door is a late 20th-century replacement. The concrete front steps feature a wrought-iron railing. Windows throughout the house are 1/1 vinyl replacements. The operable, louvered wood shutters are restrained by metal shutter dogs.

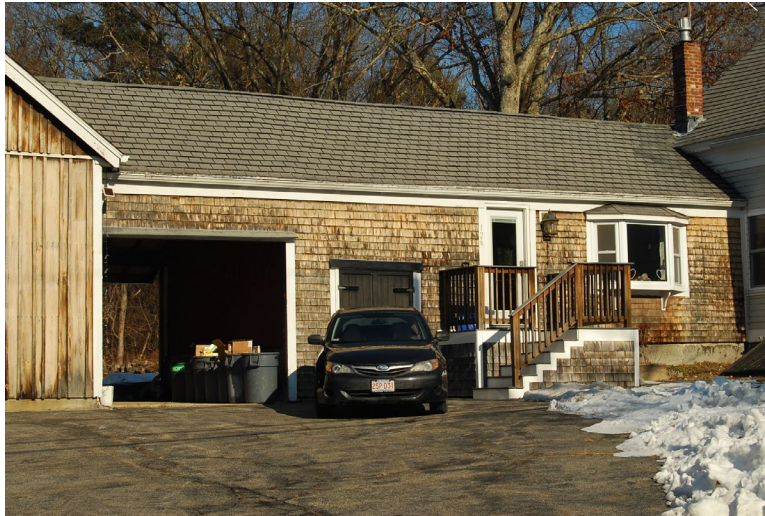
The shed/garage ell is attached to the northwest corner of the house. The one-story, side-gabled structure rests on a stone foundation and is covered with wood shingles. The east end of the ell contains a late 20th-century bay window and a wood deck that leads to a full-light door. In the center bay is located a double-leaf, side-hung, vertical board door. The west end of the ell contains a vehicle pass-through that provides access to the back yard.

Shed/garage. View looking north from Proctor Road.

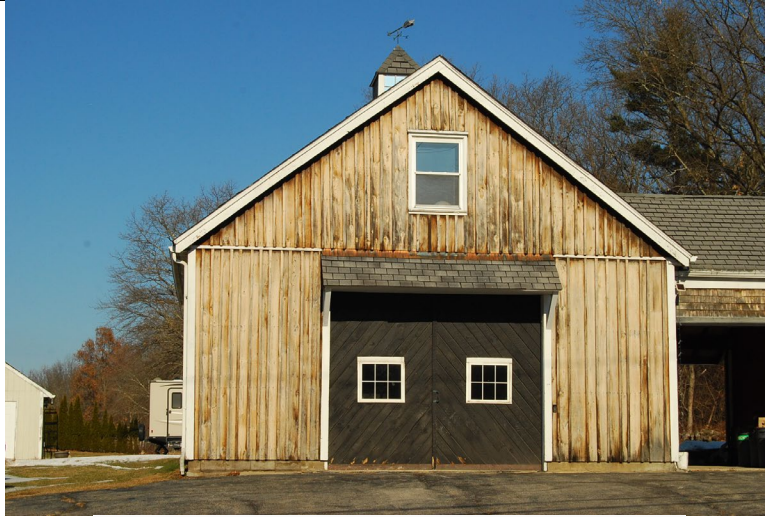
The barn is attached to the west elevation of the ell. The front-gabled roof has overhanging eaves. The building rests on a concrete block foundation. The barn is covered with vertical boards and batten. The large center door is constructed of miter-cut boards inset with six-light fixed windows. A sash window is located in the gable peak. A frame cupola rests atop the roof ridge.

Barn. View looking north from Proctor Road.
