FORM B – BUILDING

Town/City: Chelmsford

Address: 194 Tyngsboro Road

Historic Name: John and Louisa Coburn House

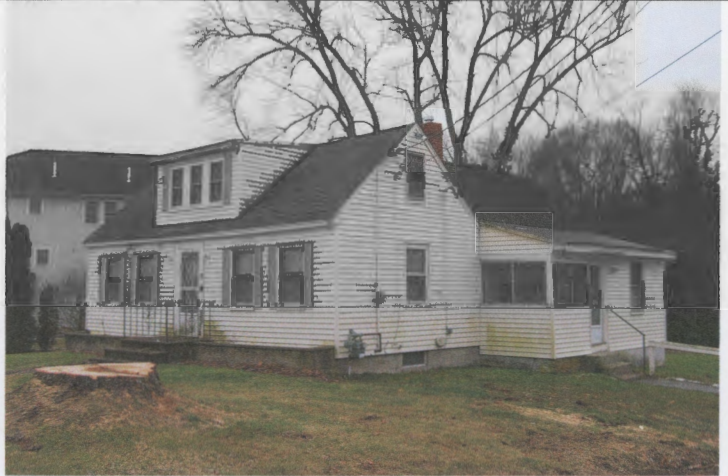
View looking south.

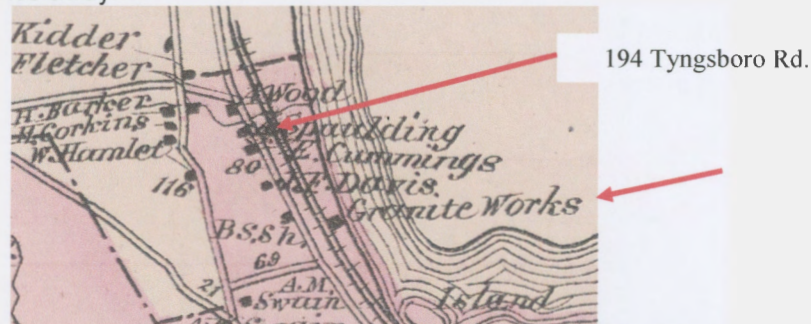
The granite works was located on the far side of the rail line near Cross Street, likely across the street from present-day 170 Tyngsboro Road. (*Atlas of Middlesex County*. 1875.)

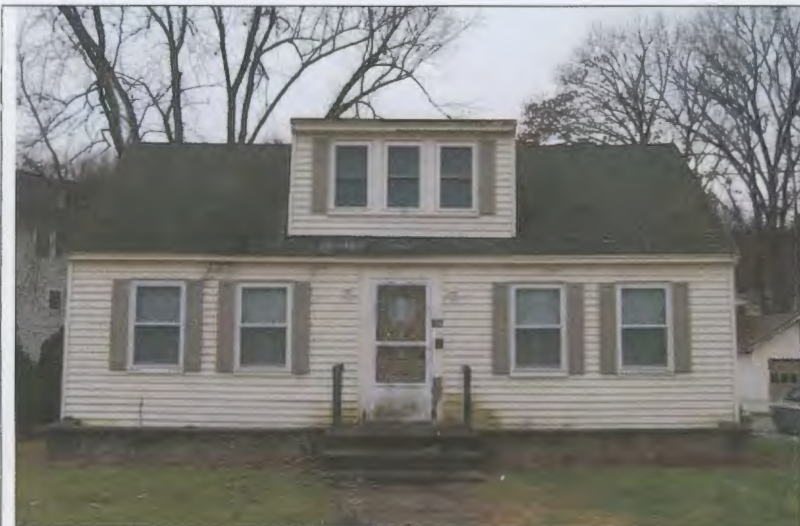
The one-story frame dwelling is five bays wide with a center entrance; the side elevations contain a single, centered bay each. The building is 30 feet wide and 15 feet deep. A single-story perpendicular ell, attached to the south end of the rear (west) elevation, is 13 feet wide and 20 feet deep. The building and ell rest on an ashlar granite foundation with beaded pointing. The front steps of the main block are constructed of poured concrete with wrought-iron railings. The poured concrete extends from the steps to form a low wall that extends in both directions along the façade to form boxes. These boxes may have been used as planters. The south end of the ell is banked; granite-lined retaining walls line the basement accessway. The three-part, side-hung basement door consists of vertical-board construction.

View looking west. Façade.

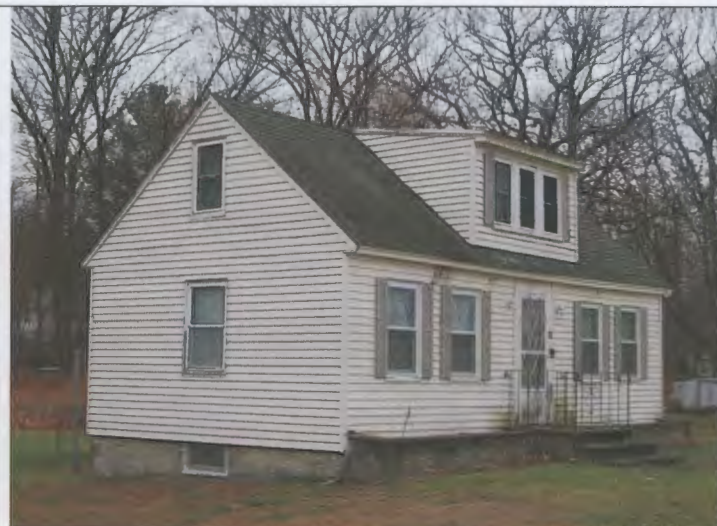
View looking northwest.

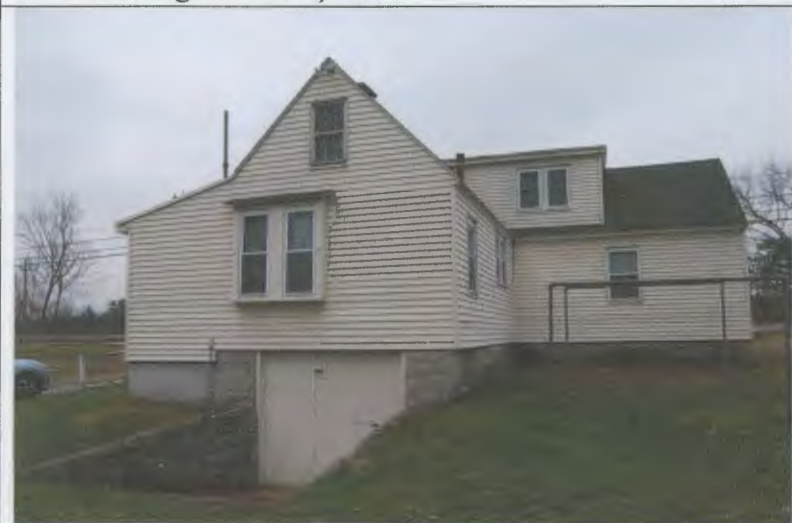
A shed-frame roof porch is attached to the north elevation of the ell. The east end of the porch rests on cut stone foundation; the west end rests on a poured concrete foundation. The east end of the porch is enclosed with four jalousie windows; the west end contains a 6/6 wood sash window on the north elevation.

View looking east at rear elevation.

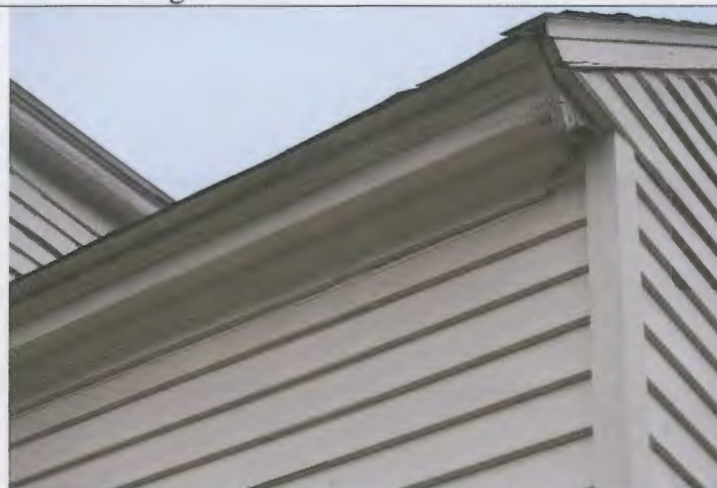
The house is capped by a side-gabled roof with shallow eaves. Shed dormers are centered on the front and rear elevations of the main block. A slender brick interior chimney pierces the north roof elevation of the ell at its intersection with the main block. The application of aluminum siding has obscured most of the wood trim; however, the rear elevation of the main block retains a shallow molded wood cornice. The wood front door dates from the mid-20th century and features two square panels below a square light. Windows throughout the building are mostly 20th-century vinyl replacements, except where indicated. 6/6 wood sash windows are located at the attic level of the main block and in the ell gable peak. The ell's rear (west) elevation contains a shallow, shed-roof box bay window. The ell's south elevation contains a pair of small 1/1 sash windows and a single larger 1/1 sash window. A fixed 6-light wood-frame window and a 3-light wood-frame window are located in the south elevation of the ell basement. A 3-light wood-frame window is also located in the basement level of the main block basement south elevation; a small rectangular replacement window is also located in the main block basement north elevation.

View looking southwest at remaining molded cornice.

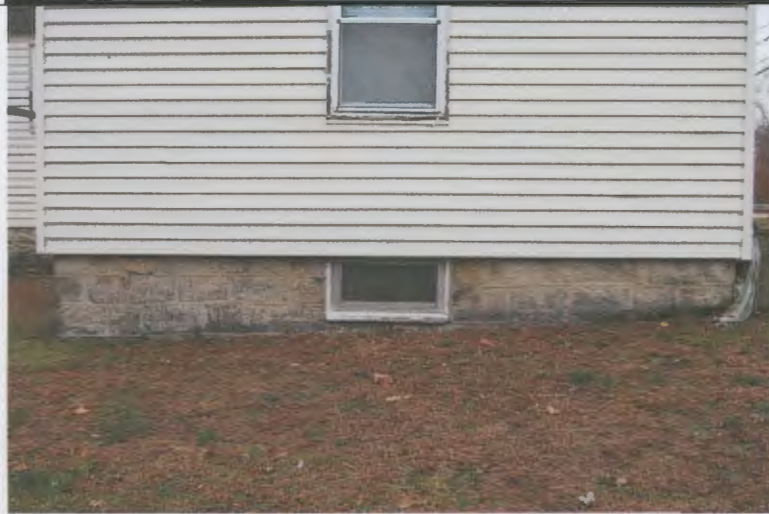
Masonry detail. South side elevation of main block.

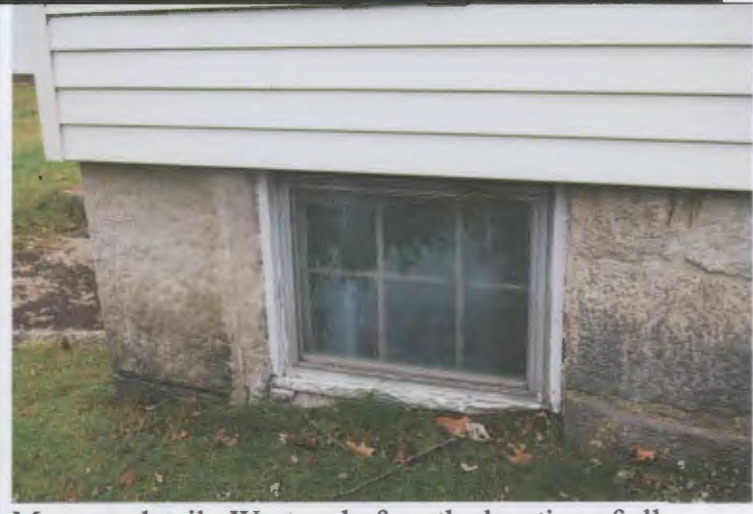
Masonry detail. West end of south elevation of ell.

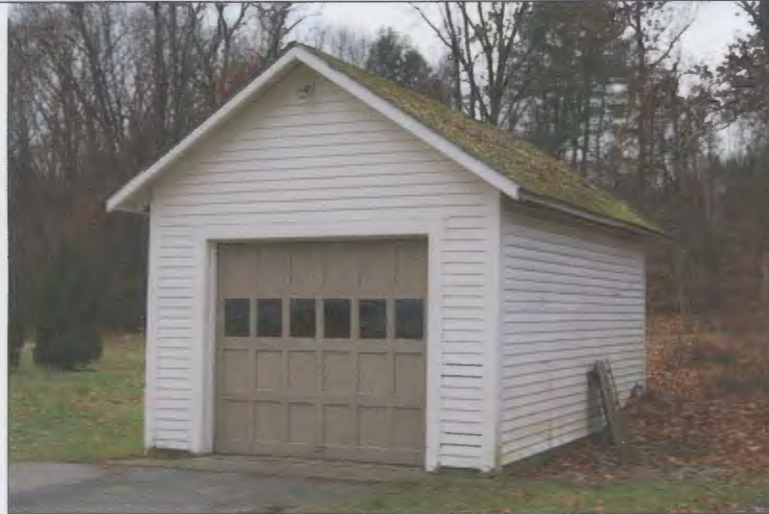
The frame garage rests on a concrete foundation and contains an overhead wood door (likely ca. 1970s) on the east elevation. The clapboard-clad building is covered with aluminum siding on the north and south elevations. The overhanging eaves have exposed rafter tails. A fixed, 6-light wood frame window is centered in the west (rear) elevation. The window's flat, wide surround is similar to that framing the garage door. A paneled metal door (Late 20th C) is centered in the south elevation.

Garage. View looking south.
